PASSAIC RIVER BASIN  
MOLLY ANN BROOK,  
PASSAIC COUNTY  
NEW JERSEY

# OLDHAM POND DAM

NJ 00238

## PHASE 1 INSPECTION REPORT NATIONAL DAM SAFETY PROGRAM

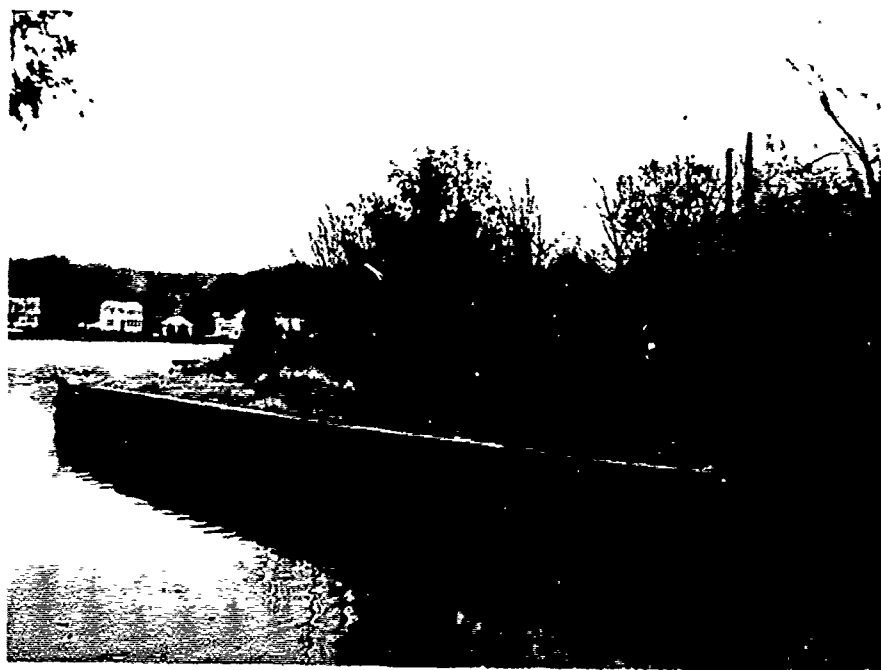
The trees growing on the downstream slope of the embankment and in the area downstream of the toe may blow over and pull out their roots or they may die with the results that their roots rot. In either case, serious seepage and erosion problems could result.

7 NOVEMBER 1979  
VIEW FROM WEST ABUTMENT SHOWING UPSTREAM FACE  
OF DAM AND HEAVY VEGETATION ON THE EMBANKMENT.
